FATIGUE FAILURES IN INDUSTRY – CASE STUDIES

Ž. Domazet and T. Piršić

Keywords: Fatigue cracks and failures, repair welding, FEM

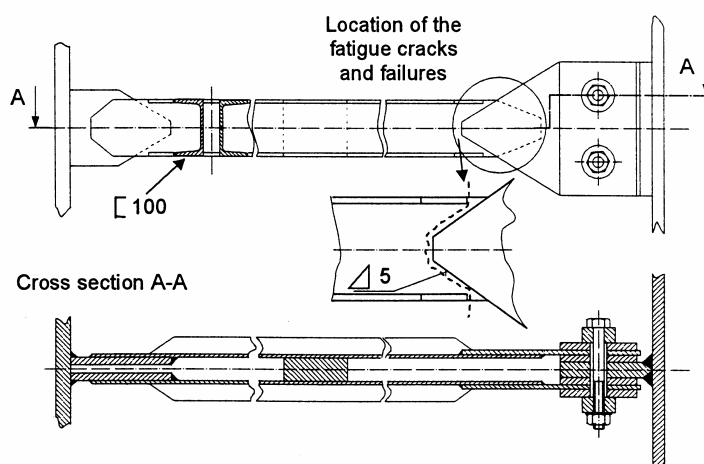
Consequence of the cracking of the supports, figure 1, is obligatory stopping of the main engine. After this had happened, the crew usually had attached additional reinforcements until new supports have been finished. Therefore crack surfaces were not examined and only crack locations were known. Supports have been cracked or failed on the location marked on figure 1.

Figure 1. Lateral engine support with observed failures

Also it was not known whether crack started from the middle of the beam and spread towards edges or vice versa. After cracking one of the supports, loads were probably redistributed, each time in a different manner. According to the description of cracks and failures, it was obviously that fatigue of material took a place again, and its causes should be detected by detailed stress analysis.

the range of design load values. Measurements gave no significant bending moments. The results of nominal stresses ($\sigma = 10\div 15$ MPa) could not be the reason for fatigue cracks, in spite of observed differences from one support to others. Stresses at the crack initiation points were measured to evaluate the quality of design. Three strain gages (15, 16 and 17) were used for extrapolation of maximal stresses. Maximal stresses at the welds toe are extrapolated. Their amplitudes vary depending on weld design but measured values of 70 or even 80 MPa could easily cause the initiation and propagation of fatigue cracks.

According to existing S-N curves for such weldments and determined maximal stresses, it is possible to predict the fatigue life of approx. 5×10^6 cycles, or a few weeks of service. This service life is too short, compared with expected 20 years. This prediction is in good agreement with the time to failure observed on former ships. Failures are mainly caused by inadequate joint design, of the support and ship (hull) structure from one side, and insufficient weld quality. Namely, stress concentration factor at critical area $\sigma_{loc}/\sigma_{nom} \approx 5$ is quite unacceptable. It should be not more than $2 \div 2.5$, and reconstruction of this important detail was necessary.

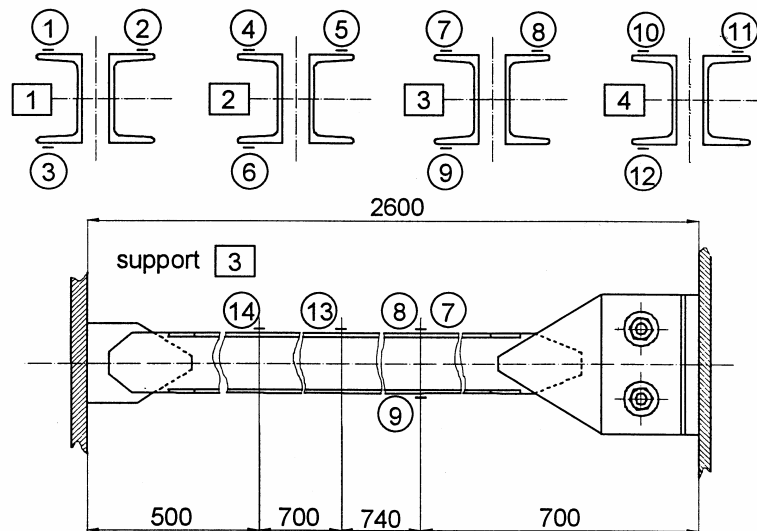
Due to complicated shape of crack area stress analysis was performed by means of strain gages. Strain gages were installed on all four beams (figure 2), in order to obtain operational loads (axial forces and bending moments).

Figure 2. Setup of the measurements for nominal stresses determination

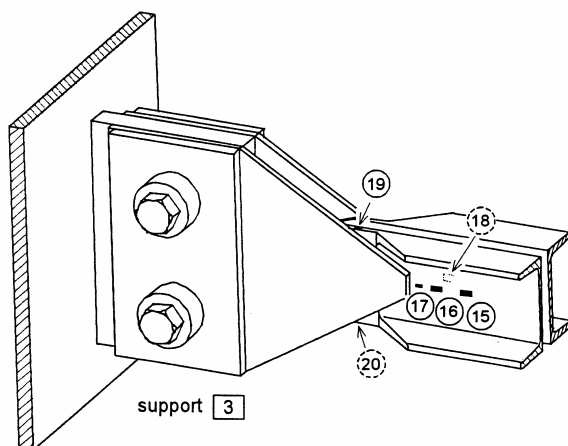
Figure 3. Strain gauges for local stress determination

The measurements took place during the sea trial of the new ship from the series. Measurement of local stresses was done at the locations of crack initiation spots, i.e. at the spot of the maximal stresses. As the observed bending moments were negligible, attention was put on the middle of the joint. In order to obtain maximal stress, three strain gages were applied (15-17), figure 3. As all four supports were not manufactured geometrically identical, on the other side of support 3, strain gage 18 is applied as well as gages 21, 22, 23 on supports 1, 2, 4, respectively. The significant difference of measured axial forces between supports was discovered. One of the beams was loaded with approx. 50% lower load. However, maximal axial force $F = 20$ kN (calculated from the nominal stresses) was within

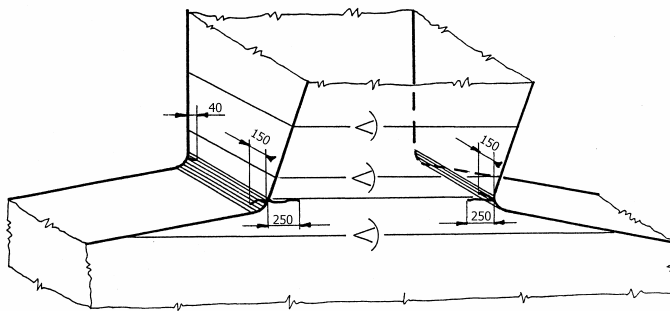
The cracks occurred at transition areas from vertical to horizontal supports on both legs, growing from the corners and bringing into danger the whole construction, figure 4. First cracks were detected soon after the crane was placed in the shipyard, so the allowed carrying capacity was reduced from 250 kN to 50 kN, but the cracks continued to grow. In order to find the source of crack initiation and

Figure 4. Detected cracks

growth, the complete documentation and calculations were checked. It was found that calculations were performed by using the simple beam elements, without taking into account the stress concentration, and the influences of inertial forces and wind were underestimated. Those facts led us to perform the complete static and fatigue analysis, to measure the real stresses during the typical manoeuvres and to redesign the critical places of the crane.

Sharp transition from vertical to horizontal plates at crane leg caused the initiation and growth of fatigue cracks that brought into danger the whole construction. By replacing the plates that contained cracks and applying the stiffeners at the places of cracks initiation, the sources of fatigue damages are removed and the maximum stresses at redesigned construction are lowered to approximately one half of previous values. Later examinations of the crane construction approved the success of this repair – two years after repair no new cracks were detected.

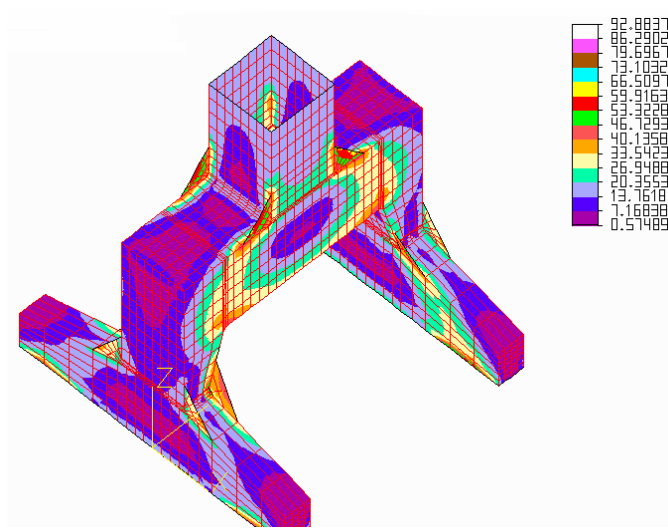
- all six degrees of freedom on the nodes at the bottom contour of model were constrained,
- concentrated forces and bending moments are distributed along the nodes on the top of the model, representing the own weight of upper part of the crane and particular load case. The complete analysis included 17 variants, with various loads, with or without stiffeners, with different orientation of crane branch and including the weight of construction. Typical results of FEM analysis are shown on figure 5.

Figure 5. Typical stress distribution

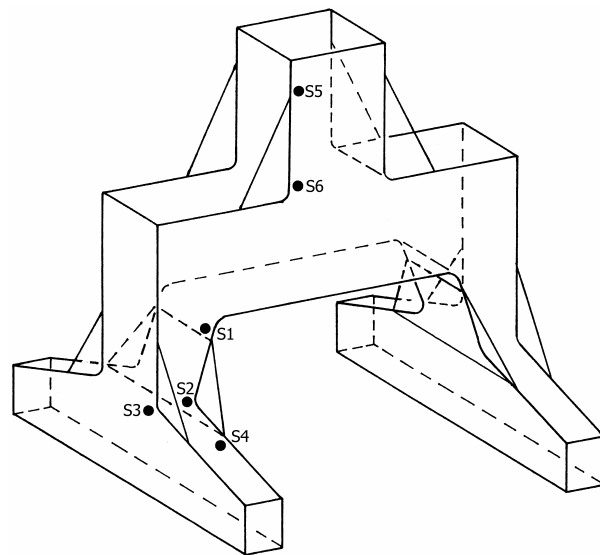
Figure 6. Positions of attached strain gauges

values predicted by FEM. Places where strain gauges were attached are shown on figure 6, and the results are shown in Table 1. Presented results are approximate, because the strain gauges cannot be attached perfectly at the same positions. According to data from Table 1., it is clear that the stresses at critical points are significantly lowered, especially in critical areas. All the stresses are under the fatigue limit, so the main source for crack growth is removed.

Strain gauge measurement and FEM analysis showed the source of crack initiation – high stress concentration in the transition areas from vertical to horizontal part of the supports. At critical points those stresses exceeded the fatigue strength of material and caused the crack initiation and growth. Variable loads cannot be avoided, so the only solution was to redesign the critical areas in order to redistribute the local stresses. FEM analysis also showed the best way for redistribution of high stresses: application of triangle stiffeners that fit the existing construction (figure 5). Those stiffeners were welded by using MAG process. The heat treatment was used to minimize the residual stresses and fatigue limit of welds was increased by grinding the weld toes and roots. After the repair was completed, stresses at critical points were measured once again and compared to the

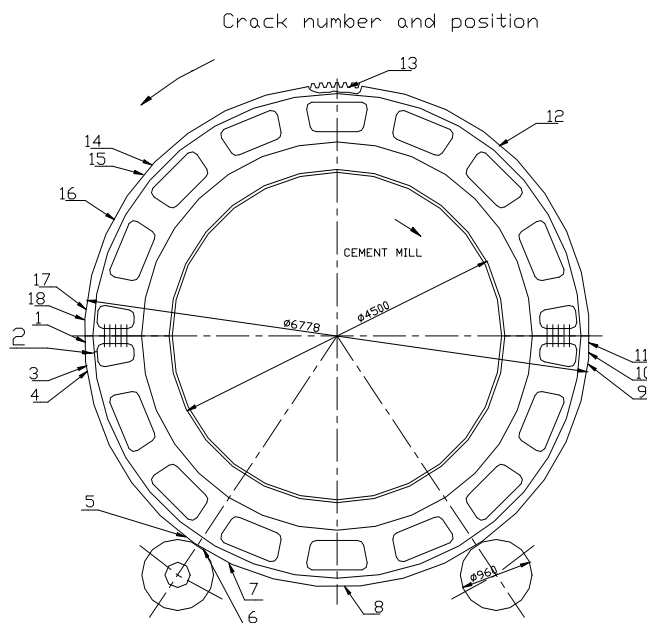
After 20 years in service, the great gear wheel of cement mill failed due to fatigue. When the whole mill plant was stopped and inspected, additional seventeen fatigue cracks have been found at the tooth fillets. The gear wheel was fabricated from cast steel and mounted in two ring parts at the front side of the cement mill, figure 7.

Figure 7. Detected cracks on cement mill

At several positions, very close to the surface, a lots of casting errors (pores, slag inclusions, etc.) have been found, figure 7. Joint efforts of alternating stresses, casting errors (sized several millimetres to several centimetres) and most likely existence of tensile residual stresses caused fatigue cracks initiation and propagation at the critical positions.

The cross section of the gear rim where complete fatigue failure occurred (fatigue crack No. 2), was additionally weakened by decreasing the rim thickness due to connecting bolts. The position of the cracks is showed on figure 7. The surface crack length varied from 20 mm to 600 mm (total failure). Position and size (surface length) of each discovered crack were estimated by means of non-destructive testing (magneto-flux method). In order to determine the complete data on crack shape and size

to determine the stress distribution at the gear rim. Calculated maximum stress amplitudes have been found at the tooth fillet, approximately 50 - 115 MPa, depending on their positions at the surface. Stress intensity decreases very fast in the depth of the gear rim. These stress values could not be the only reason for cracks initiation and propagation. In spite of great number of cracks and one complete failure of gear ring, repair welding was performed. All necessary steps for the best quality insurance (best welders, best welding rods, pre-heating, very slow cooling conditions, NDT inspection following every layer, hammering of all layers, etc.) have been respected and documented. All described activities took two months and cost approx. \$50 000, instead of \$300 000 for new gear ring and four months for its delivery and montage. Three years after repair and frequent controls during the service, no further cracks have been reported.

(depth), and to perform repair welding, voluminous work (cracks removal by arc-air grooving has been undertaken.
